## Municipal Archives: Protection & Preservation

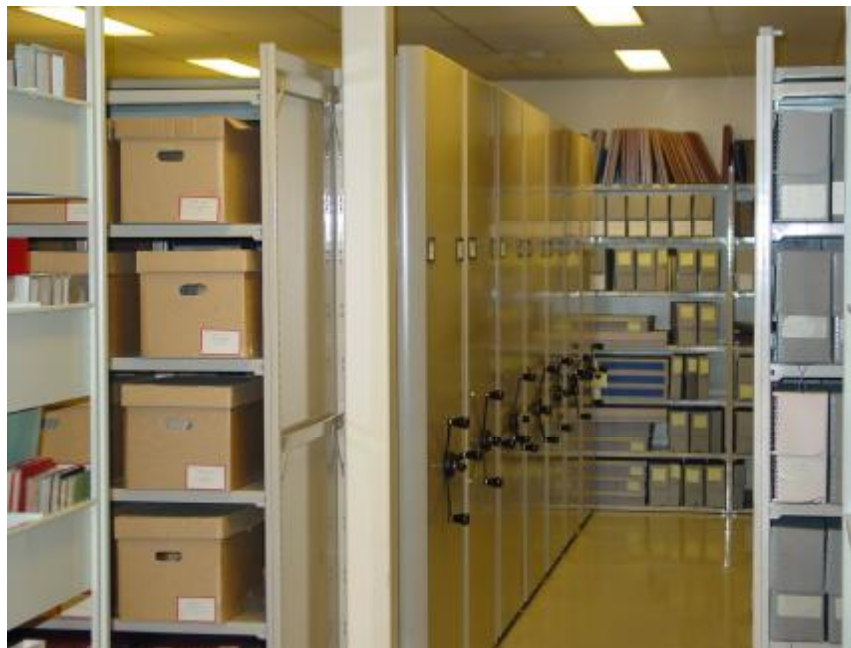
To properly address this concerns the system was installed on surface mount track without decking to alleviate flooding concerns.

All surfaces were metallic and powder coated to eliminate off gassing.

Custom all-steel end panels were designed to maintain an acid free environment.

**System:** 32 — 14' carriages  
10 — 12' carriages  
179 Shelving Units
