Municipal Archives: Protection & Preservation

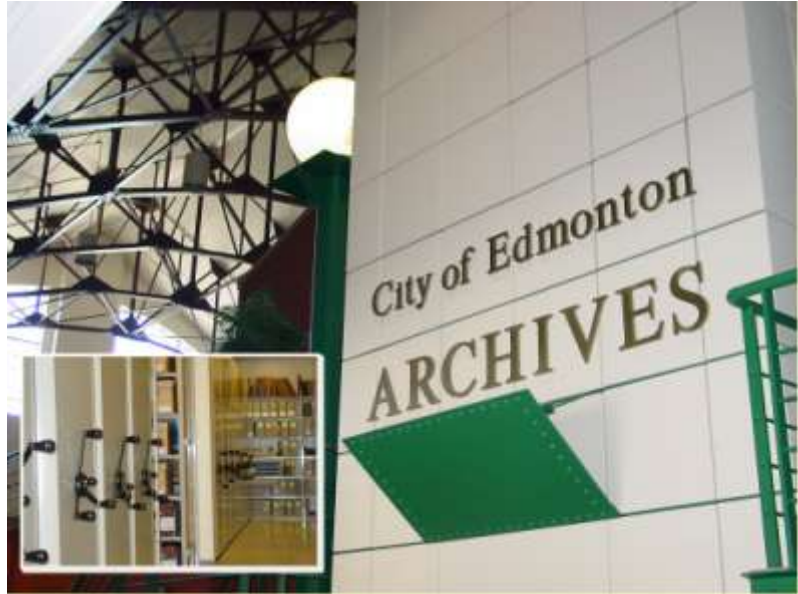
To address the flooding concern, a Mizer mobile system was installed using "low profile" track; (without decking) this removed any possibility of flood damage to a sub-deck and the lower level collections.

All surfaces were metallic and powder coated to eliminate off gassing and to maintain an acid free environment.

System: 32 — 14' carriages
10 — 12' carriages

Totalling 179 double faced shelving units compacted on Mizer carriages.
